## FIRE PROTECTION ON A CURVE: ANSWERING THE CHALLENGE OF CURVED FABRICATION

### Project Overview

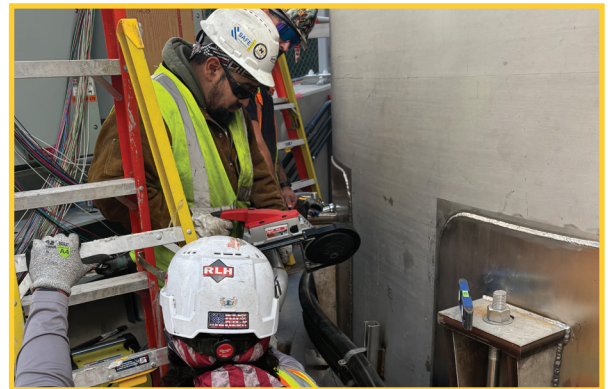
RLH Fire Protection partnered with Core & Main to develop and execute a fabrication solution. The system required 2-inch Schedule 10 stainless steel piping to be bent precisely to match each tank’s curvature while maintaining flange-to-flange connections for installation efficiency and compliance. Some grooved material also was developed.

The fabrication process involved multiple coordinated steps. Standard pipe was first prepared, then sent to a specialized bending partner, where it was curved to the required specifications. The pipe was then returned to the Core & Main Lodi facility for final fabrication, including flange installation and welding. Maintaining both the curvature of the pipe and proper sealing surfaces during welding required a high level of precision.

State inspection oversight was required throughout the welding process to ensure compliance with fire protection standards. Once completed, the pipe assemblies were mounted on engineered stabilizers, allowing the system to maintain alignment and structural integrity while surrounding each tank.
